PHOTOGRAPHIC INTERPRETATION MEMORANDUM

REPAIR ACTIVITY  
HAIPHONG PORT,  
NORTH VIETNAM

NPIC/R-101/68  
SEPTEMBER 1968

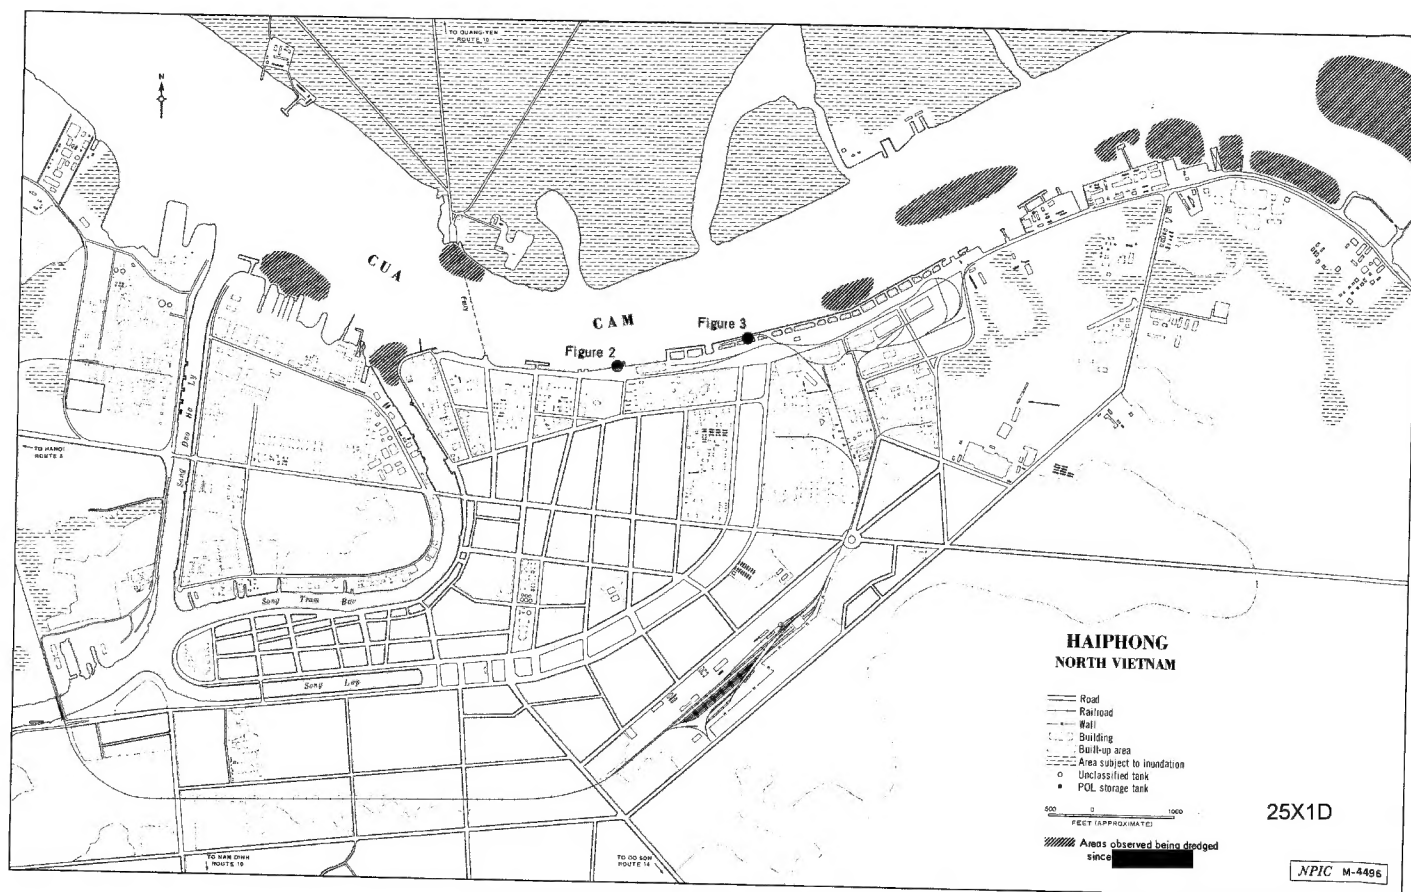
Important maintenance activity currently taking place in the port area is the dredging of the Cua Cam (Figure 1) and the Maritime Channel, which provides access to the Gulf of Tonkin. The large [redacted] suction dredge, the "1954" and "1957" bucket dredges, and numerous small suction dredges have been observed operating extensively throughout the area since 31 March 1968.

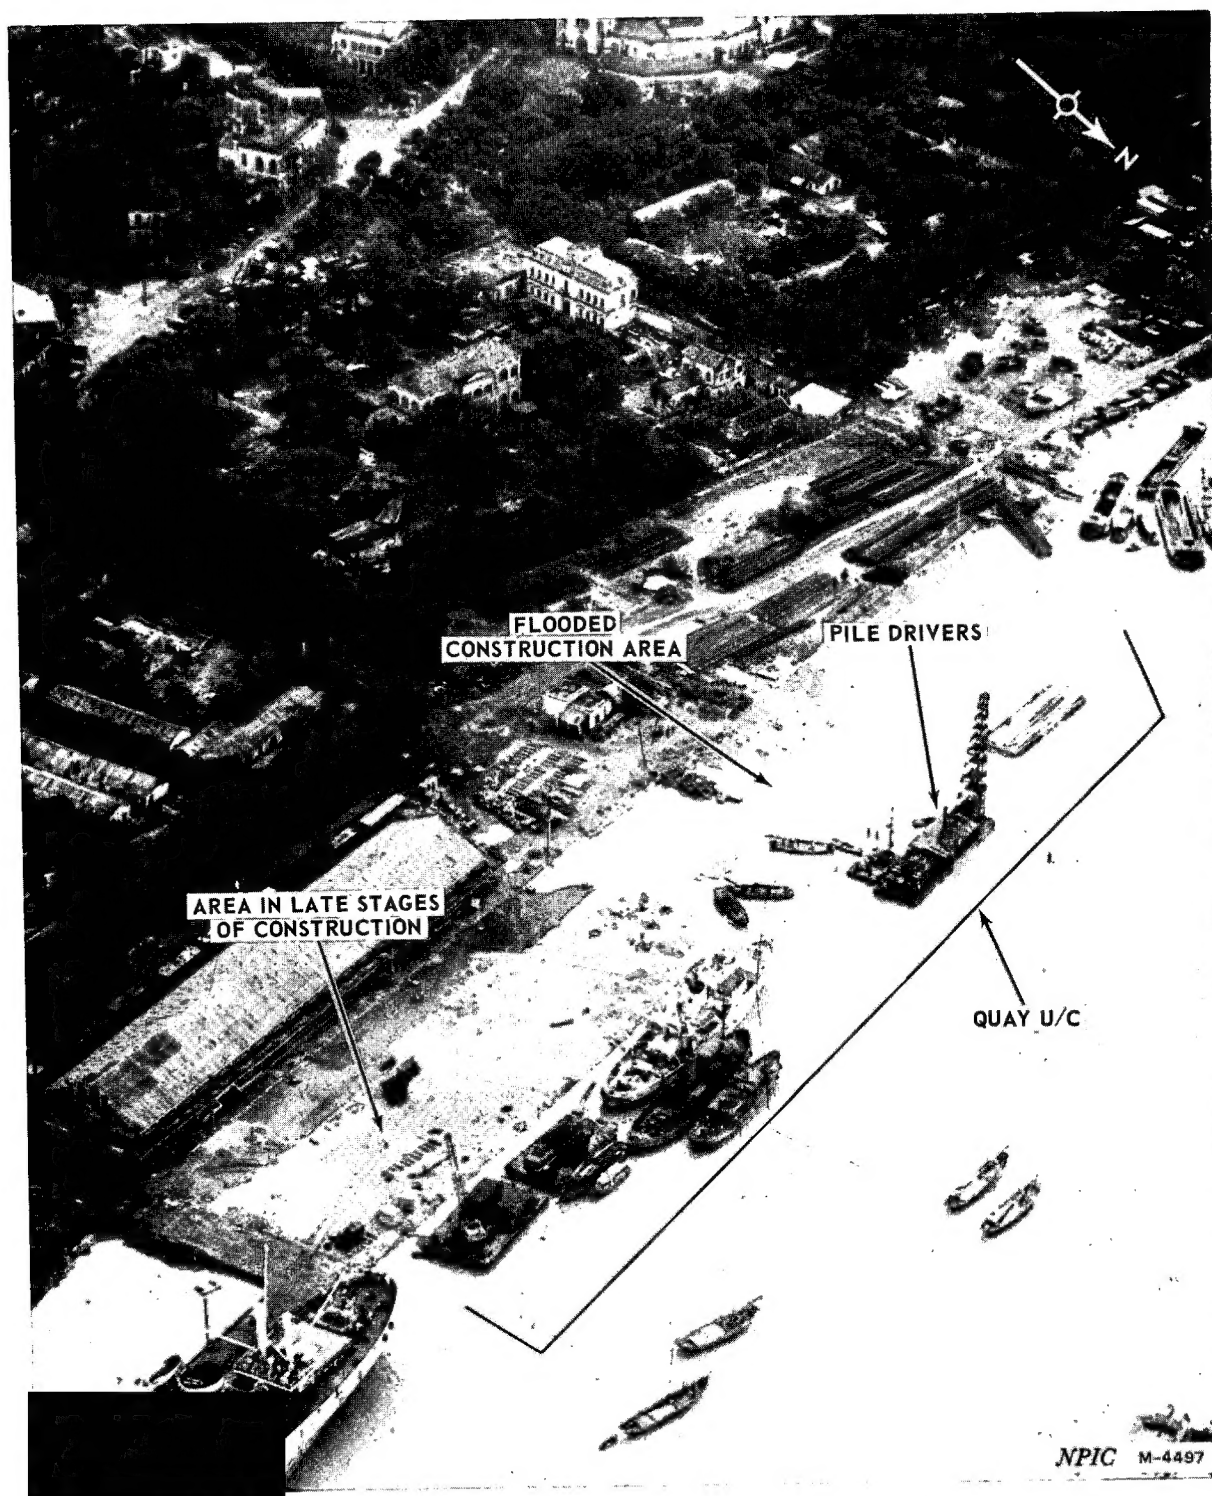
FIGURE 2. NEW QUAY CONSTRUCTION, CHAMBER OF COMMERCE WHARF, HAIPHONG.

The most significant construction activity in the port is the new quay extension to the Chamber of Commerce Wharf (Figure 2). When complete, this quay will be able to accommodate at least two merchant ships, bringing the total berthing space available at the port to approximately 13 ships. Numerous vessels have been observed off-loading their deck cargo directly onto lighters in the channel, because all available berthing spaces were in use.

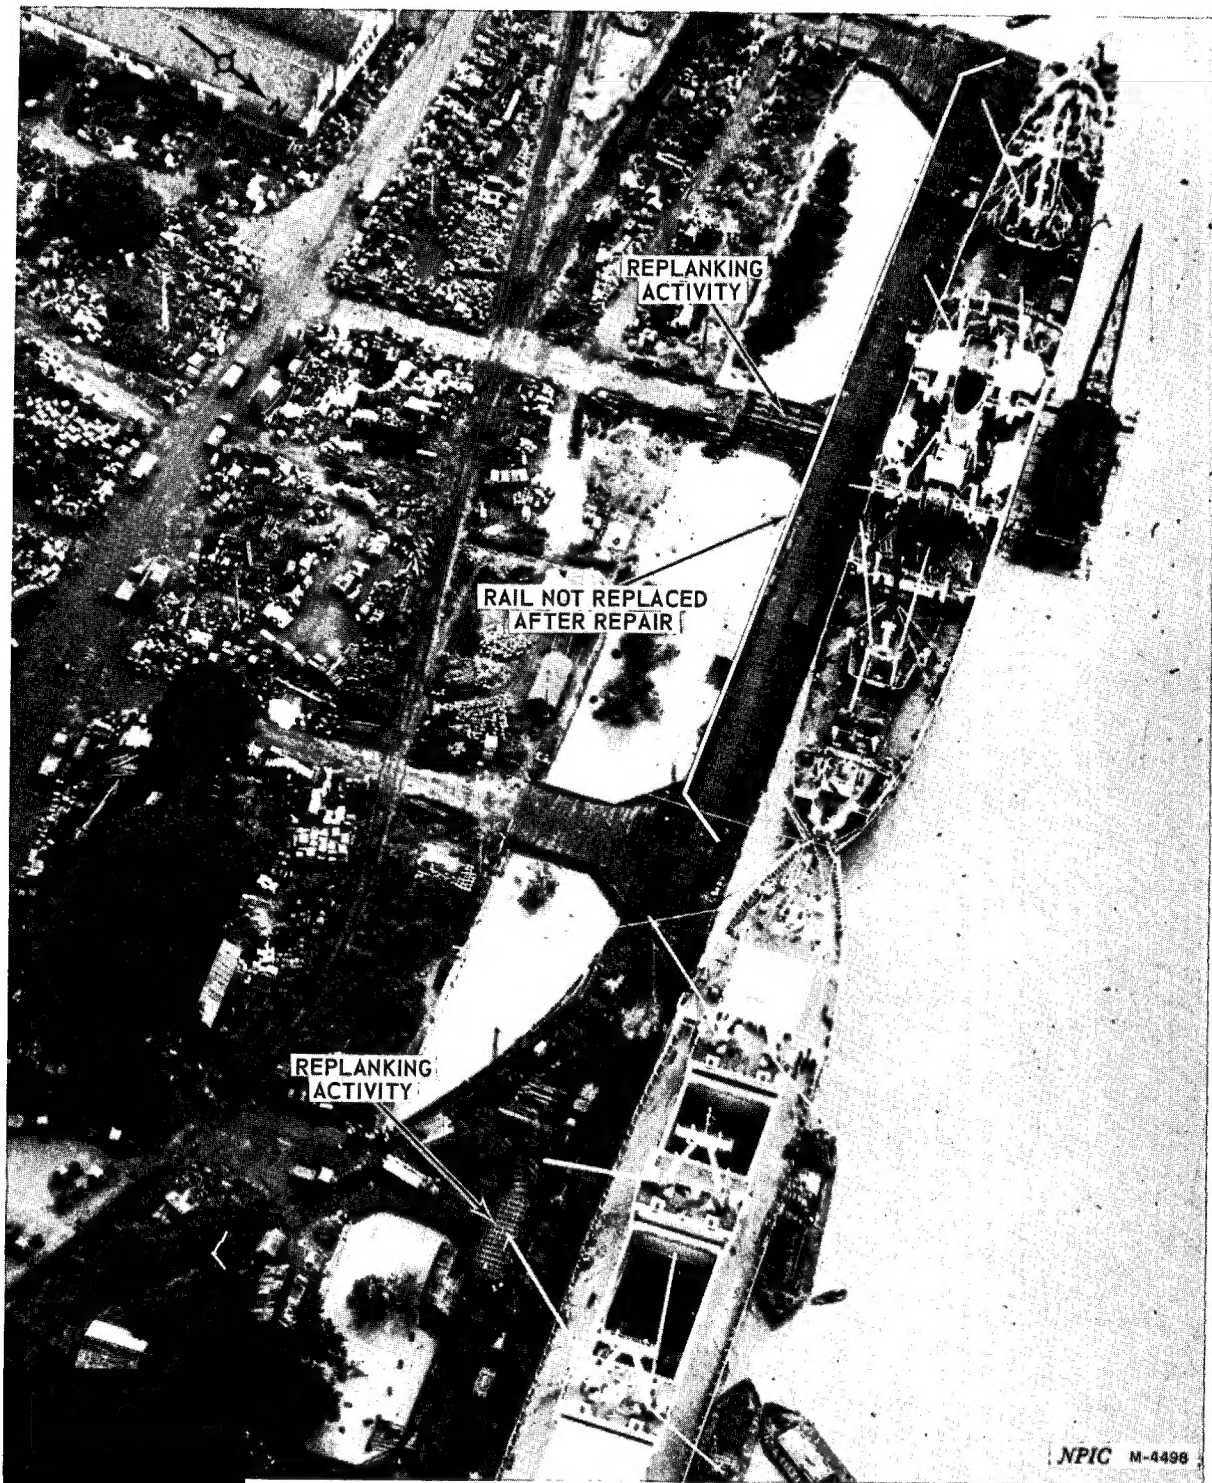
FIGURE 3. REPAIR ACTIVITY, CHAMBER OF COMMERCE WHARF, HAIPHONG.

Extensive repair work and replacing of planking has been observed at several locations on the Chamber of Commerce Wharf (Figure 3). This repair activity apparently has not presented significant obstruction to the off-loading of ships in port, since the turn-around time has decreased in recent months. A rail spur has been removed from the Chamber of Commerce Wharf and there are no indications that it will be replaced at the present time. There are still several areas of deteriorated planking along the port which are in need of repair.
